SUBJECT: LEXUS SPECIAL SERVICE CAMPAIGN #902

SPECIAL SERVIC- CAMPAIGN #902 - CENTER HIGH MOUNTED STOP LAMP

RE: NHTSA Recall Campaign 89V-212

DEFECT INFORMATION REPORT1. Manufacturer Corporate Name:

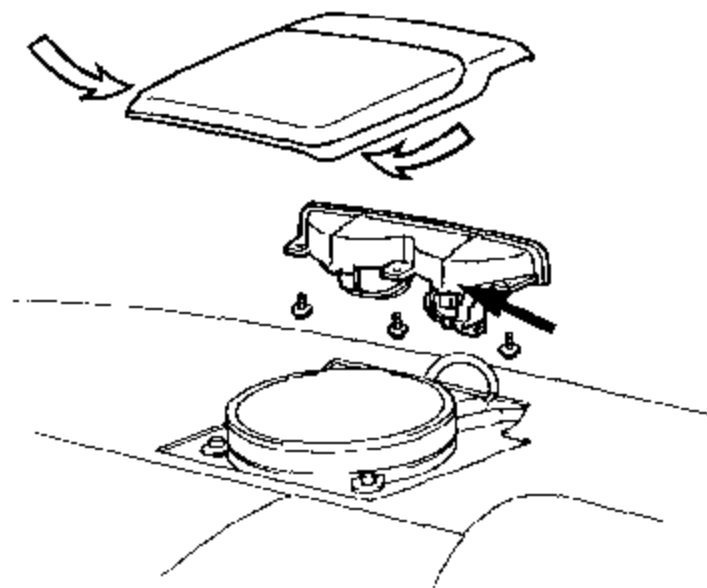
1. Check letters embossed on lamp housing (indicated by black arrow). If the letters are "PA", reinstall the original lamp assembly. If the letters are "PP", replace the lamp assembly with a new one.

1. Remove the three screws and separate the high mount stop lamp from the woofer speaker cover. Use care when installing new lamp assembly as the lens is a tight fit in the woofer speaker cover.

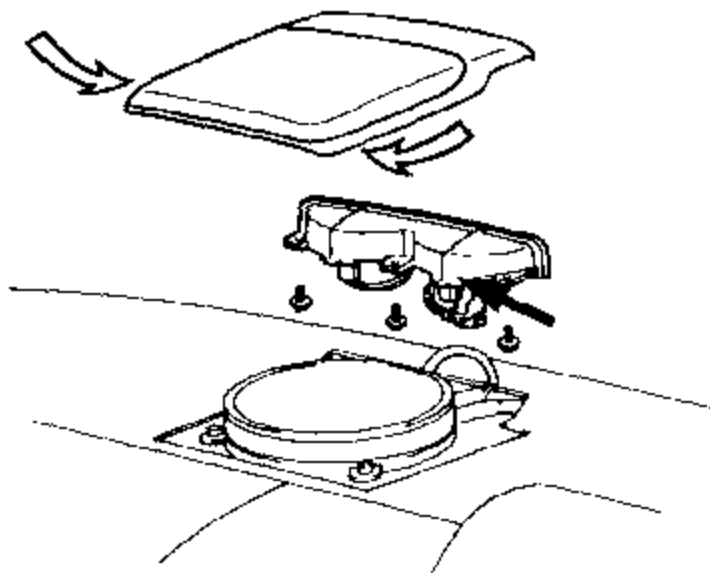
1. Check letters embossed on lamp housing (indicated by black arrow). If the letters are "PA", reinstall the original lamp assembly. If the letters are "PP", replace the lamp assembly with a new one.

1. Remove the three screws and separate the high mount stop lamp from the woofer speaker cover. Use care when installing new lamp assembly as the lens is a tight fit in the woofer speaker cover.

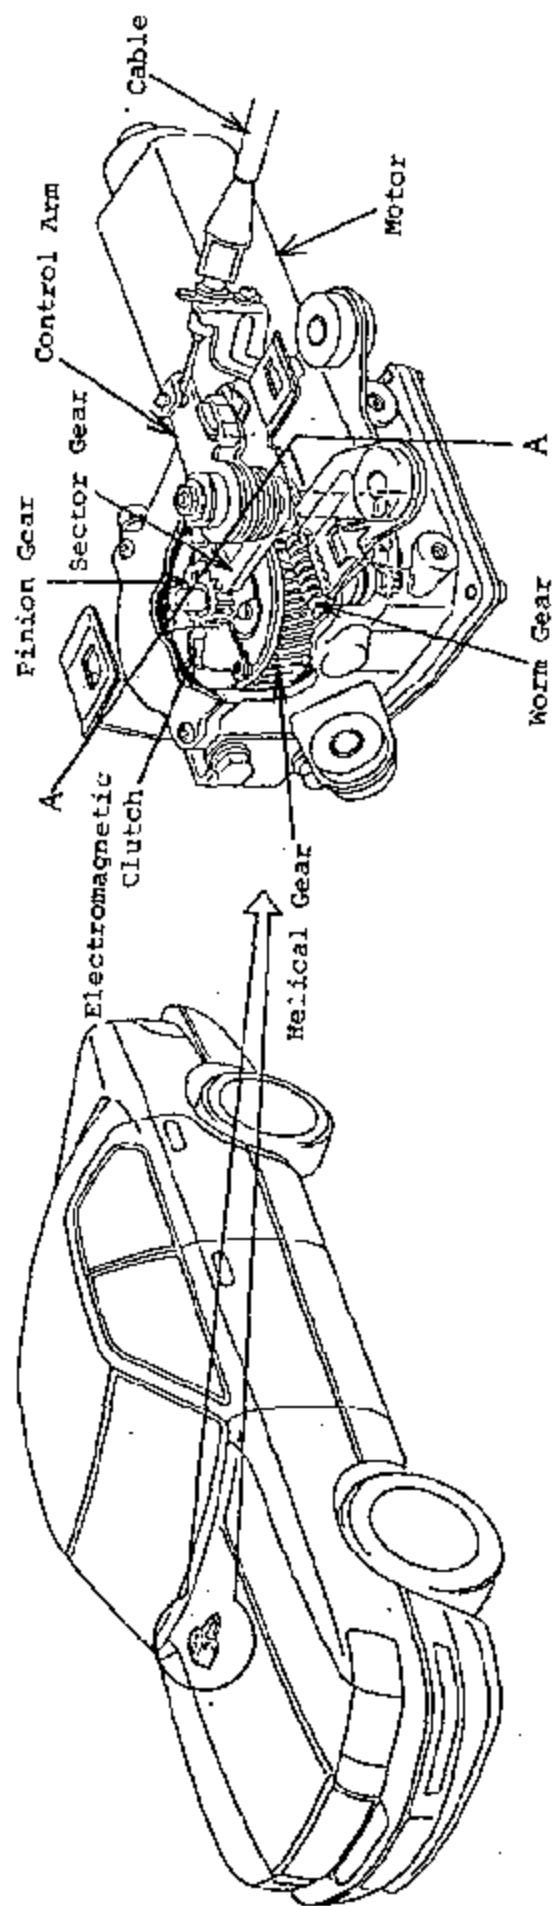
Fig.1

Figure 1 shows the structure of the subject cruise control actuator. The force controlling the throttle opening is transmitted to the throttle body from the motor through the worm gear, helical gear, electromagnetic clutch, pinion gear, sector gear, control arm and cable.

Failure Part
(Electromagnetic Clutch)

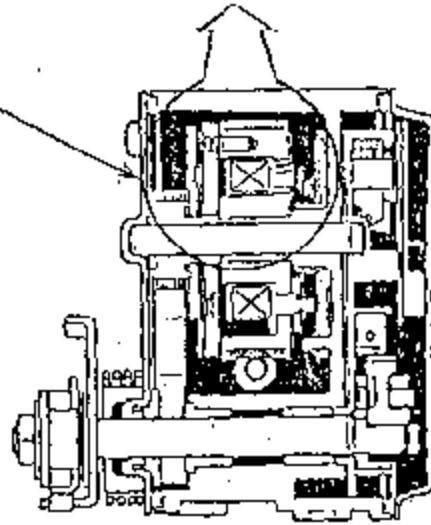
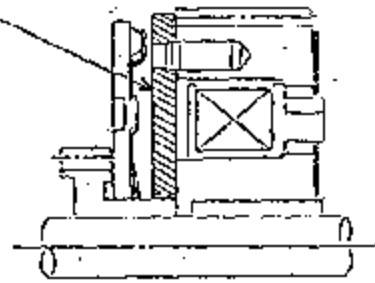
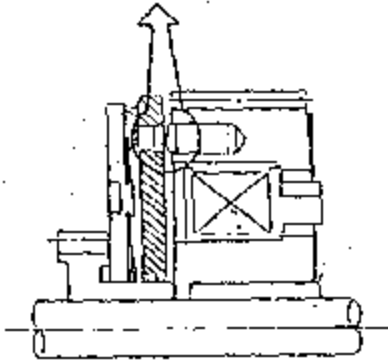
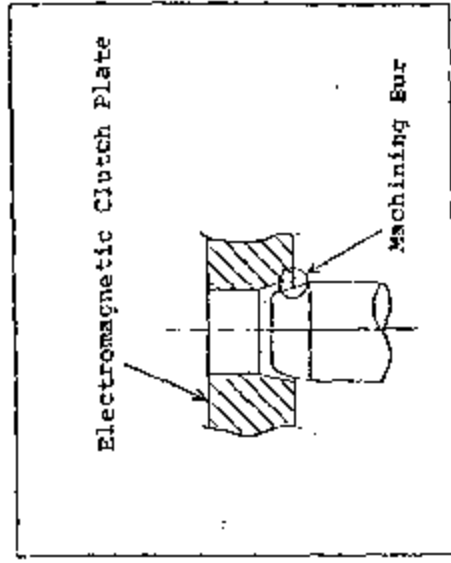
Fig.2

A defective cruise control actuator may not release from its most recent setting, due to the possible presence of a machining bur in the clutch plate hole of the electromagnetic clutch from the machining process.

Figure 2 shows the cross-section of the subject cruise control actuator, the operation mechanism of the electromagnetic clutch and the location of the possible machining bur.

The machining bur elimination process was added in the machining process as the corrective action.

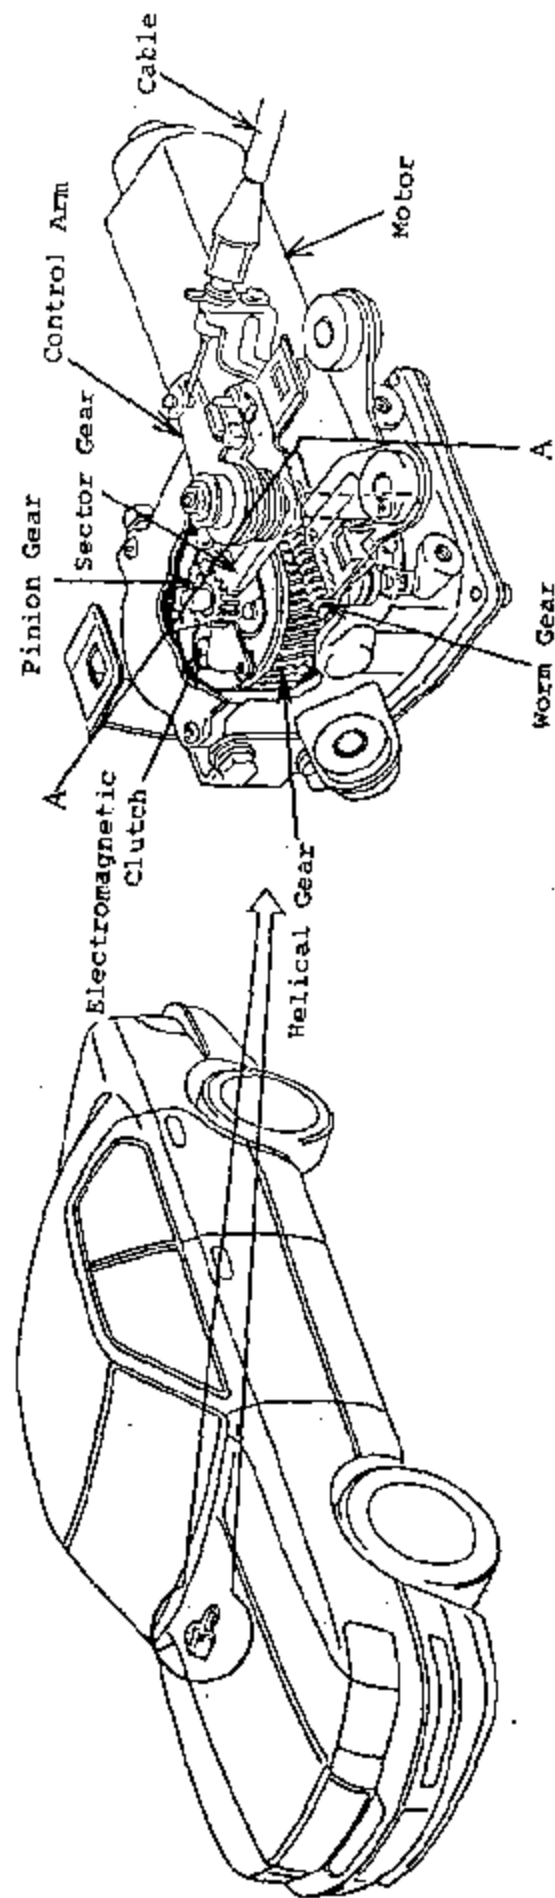
Fig.1

Failure Part
(Electromagnetic Clutch)

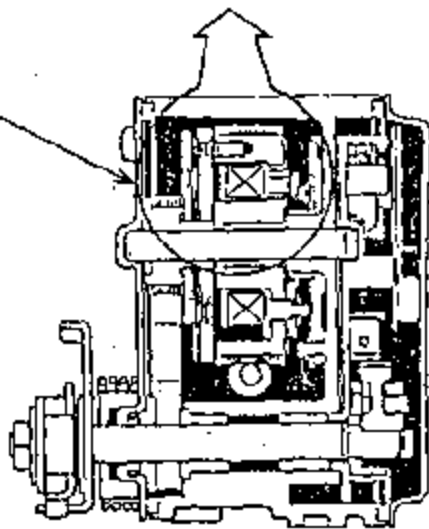
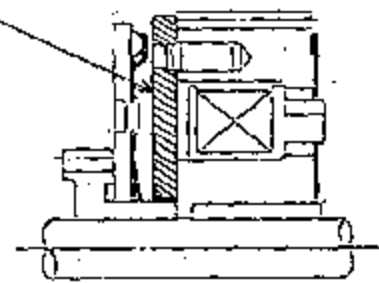
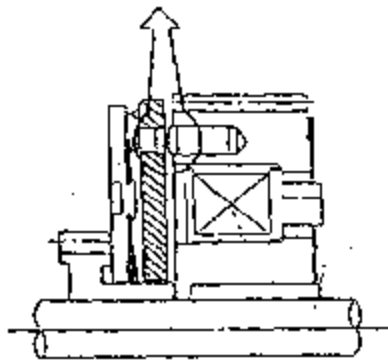
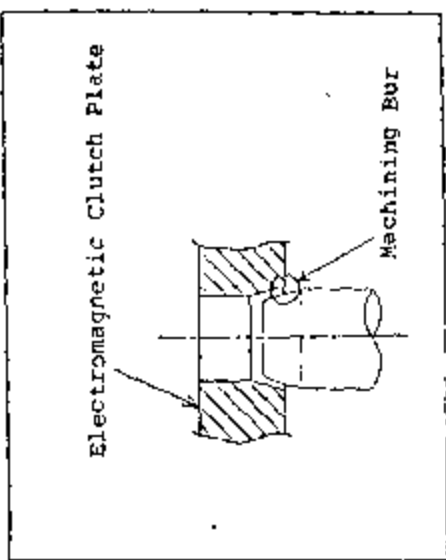
Fig.2

A defective cruise control actuator may not release from its most recent setting, due to the possible presence of a machining bur in the clutch plate hole of the electromagnetic clutch from the machining process.
